**DEPARTMENT OF TRANSPORTATION****DIVISION OF ENGINEERING SERVICES**

Contract #: 04-0120F4Cty: SF/ALA Rte: 80 PM: 13.2/13.9File #: 69.28**WELDING INSPECTION REPORT****Resident Engineer:**Pursell, Gary**Address:** 333 Burma Road**City:** Oakland, CA 94607**Report No:** WIR-014366**Date Inspected:** 19-May-2010**Project Name:** SAS Superstructure**OSM Arrival Time:** 700**Prime Contractor:** American Bridge/Fluor Enterprises, a JV**OSM Departure Time:** 1900**Contractor:** Zhenhua Port Machinery Company, Ltd (ZPMC), Changxing Island **Location:** Shanghai, China**CWI Name:** Li Yang**CWI Present:** Yes No**Inspected CWI report:** Yes No N/A**Rod Oven in Use:** Yes No N/A**Electrode to specification:** Yes No N/A**Weld Procedures Followed:** Yes No N/A**Qualified Welders:** Yes No N/A**Verified Joint Fit-up:** Yes No N/A**Approved Drawings:** Yes No N/A**Approved WPS:** Yes No N/A**Delayed / Cancelled:** Yes No N/A**Bridge No:** 34-0006**Component:** OBG**Summary of Items Observed:**

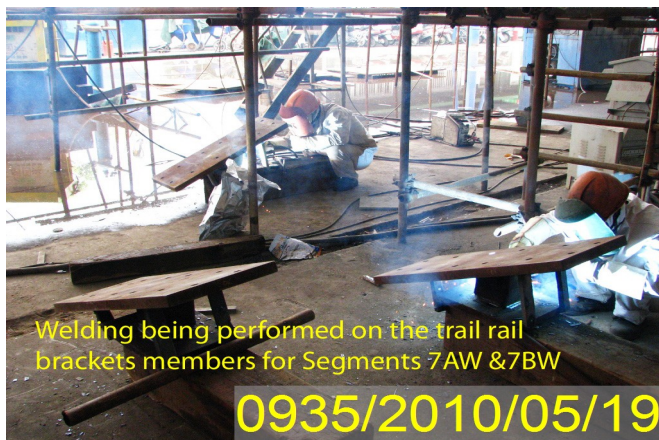
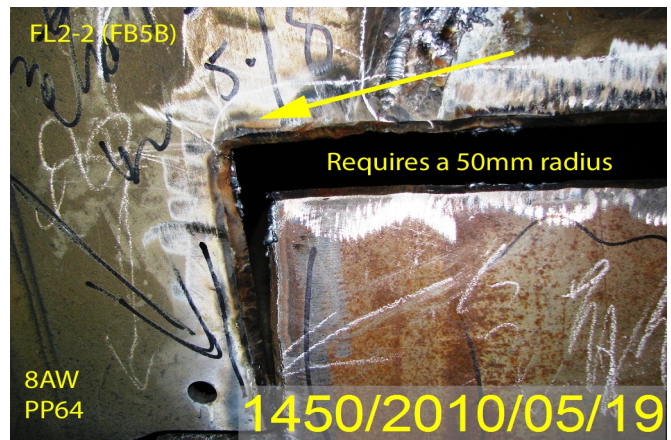
8AW

This QA Inspector observed ZPMC personnel had cut damaged area FL2-2 web to bottom plate. This QA Inspector noted ZPMC had deviated from repair procedure. Repair plate member corners did not have the proper radius (50mm) per RFI-GGL-MQ-1573. This QA Inspector issued an incident report for noted issue on today's work shift.
